The following article is information extracted from correspondence from Impact Instrumentation, Inc. regarding the 754M Ventilator, NSN 6530-01-464-0267. It relates to the failure of the compressor motor, and recommended actions to be taken by units in possession of the ventilator.

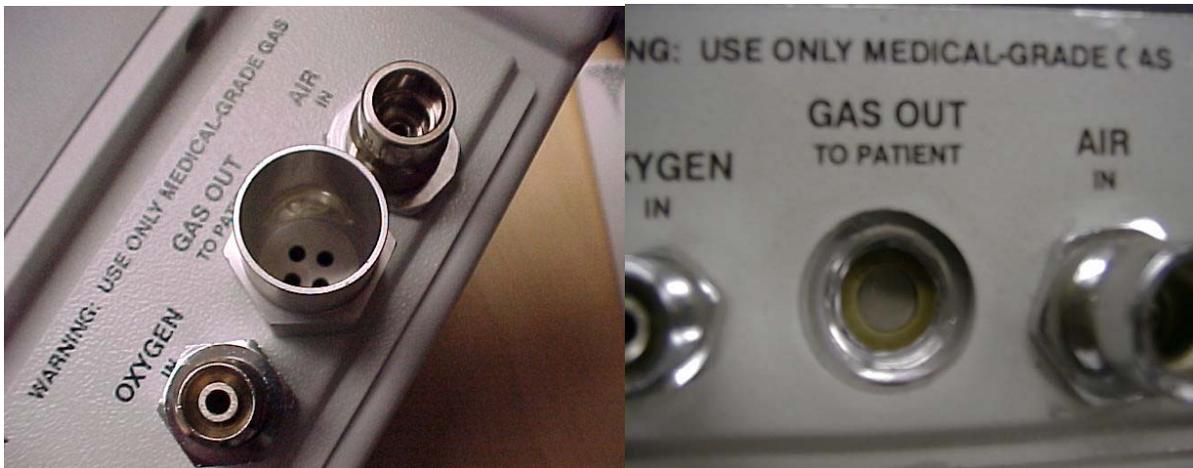
“Gas Out” Connection”

The "Total Flow Backup" alarm could be a direct result of unclean ambient air being entrained into the ventilator via its compressor intake assembly. Entrained dust and debris can accumulate on the flow sensing screen and inadvertently trigger the particular alarm.

Connection removed – see filter

Remove the "Gas Out To Patient" fitting at the top of the vent (there will be an o-ring and screen underneath), and clean the flow sensing screen. The screen can be cleaned using oil less compressed air. Inspect by holding screen up to a light source. The picture shows the fitting removed and the screen in view. An additional factor that could cause an alarm is a defective Mix Flow Transducer or a hardware calibration issue.
